Line of Duty Death
Board of Inquiry Report
Lieutenant James E. Bethea

710 E. North Avenue

November 12, 2014

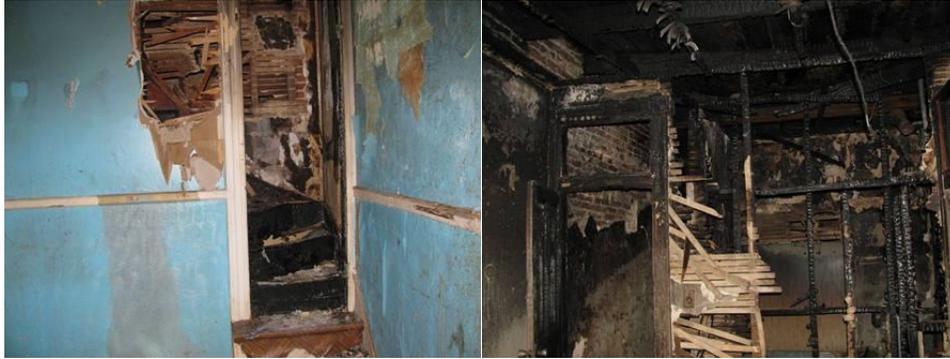
The fire originated in the rear interior stairway to the second floor. There were signs of burning of the tread and riser of the fourth step with extension to the entire stairway. The riser above the fourth step had heavier burning and showed a distinct burn pattern. All the treads in the staircase had a linoleum type product covering them with burning to same. The leading edge of the treads in the staircase had what appeared to be aluminum alloy skid resistance plates. Melting of this alloy was noted and molten material had dripped down to lower risers/treads. The fire extended to and burned the stairway ceiling and wall covering causing them to drop down into the stairway. The fire extended to and burned the wood structural members of the wall and ceiling of the stairway. The fire burned through the south and north partition walls of the stairway. The fire extended to and burned the adjacent second floor rear room and the adjacent second floor bathroom. The fire extended to and burned the upper level of the second floor hallway. The fire continued to burn the wood floor joists of the underside of the third floor wooden floor. The fire extended to and burned the upper level portion of a wooden door leading into second floor front room. The fire also burned the ceiling inside that door. The fire caused smoke damage to all of the second floor rooms. The fire caused smoke and soot damage to the stairway to the third floor and all of the third floor rooms. The fire caused smoke damage to the rear portion of the underside of the third floor wood floor joists of exposure delta. Soot deposits were also observed in the basement of the delta exposure's open joist pockets.

(Photos above taken by Captain Flynn on 12-02-2014. Left photo shows the rear stairwell on the first floor of 708. Right photo shows the rear stairwell on the second floor of 708.)

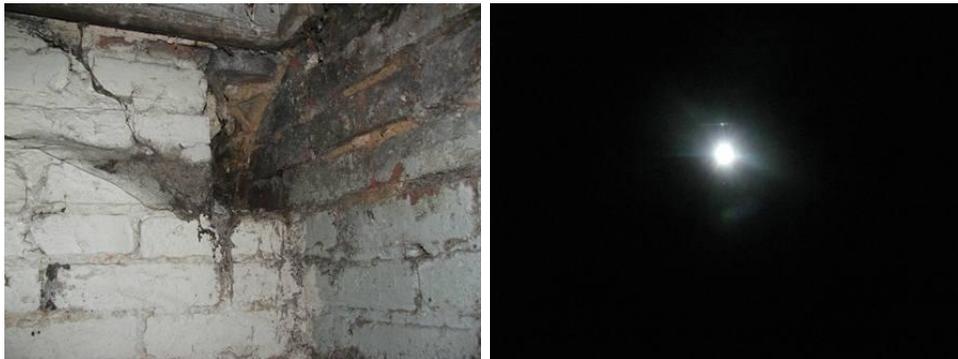
(Photos above taken by Captain Flynn on 12-09-2014. Left photo shows soot deposit in the basement of exposure delta. Right photo is taken without light in exposure delta and a flash light in the fire building, showing the open joist pocket. There were several other joist pockets that had similar properties between 708 and 710.)

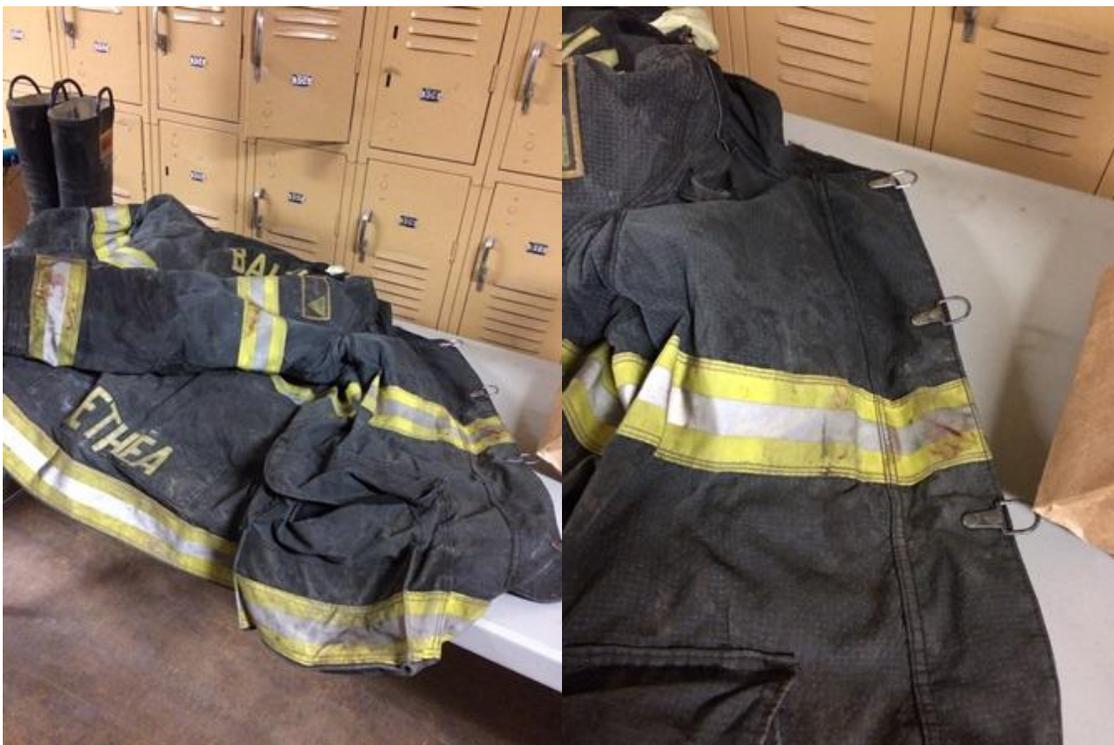
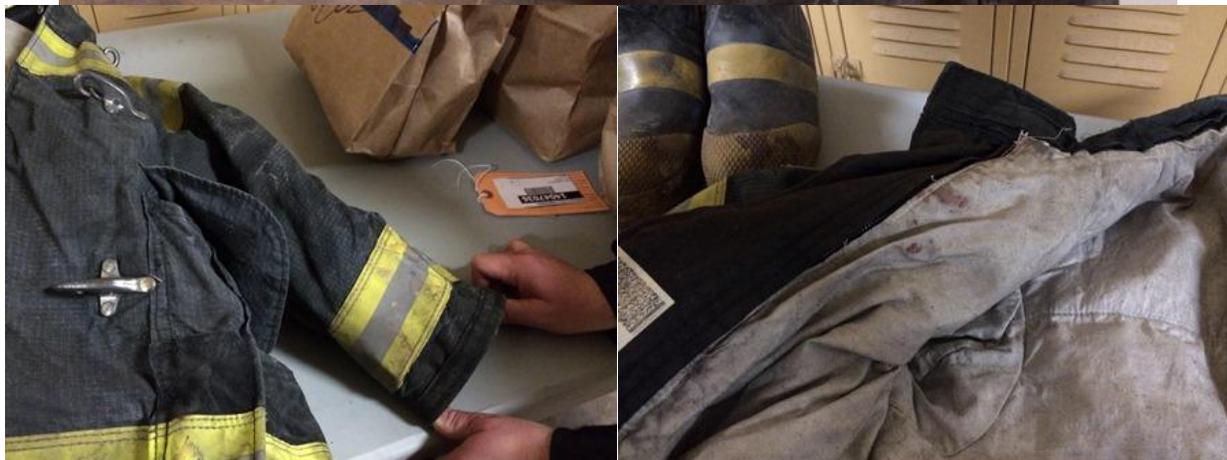
Turnout Coat

- Right sleeve, including the reflective strip (majority on lower half)
- Right front, including the reflective strip
- Left sleeve
- Right side, upper part, in the interior liner
- Both left and right wristlets

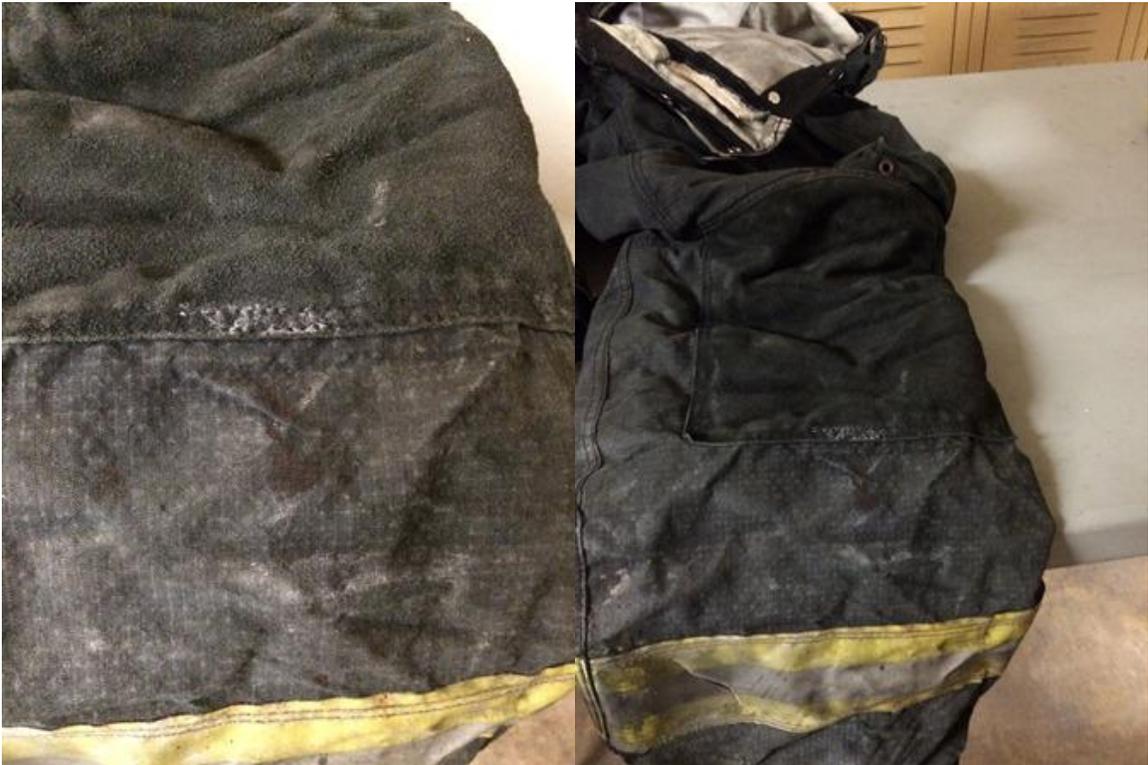
Turnout pants

- Left leg, upper front, and below the knee pad
- Right leg, rear upper portion

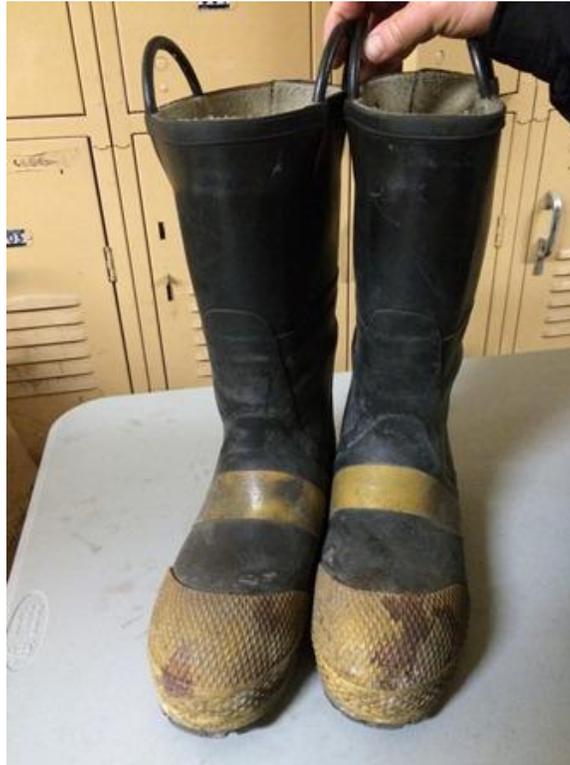
Boots

- Top/front portion of both boots

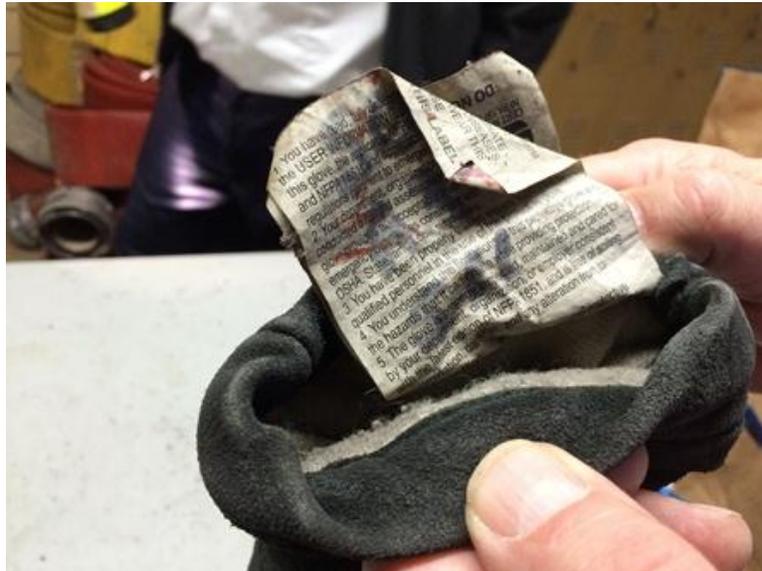
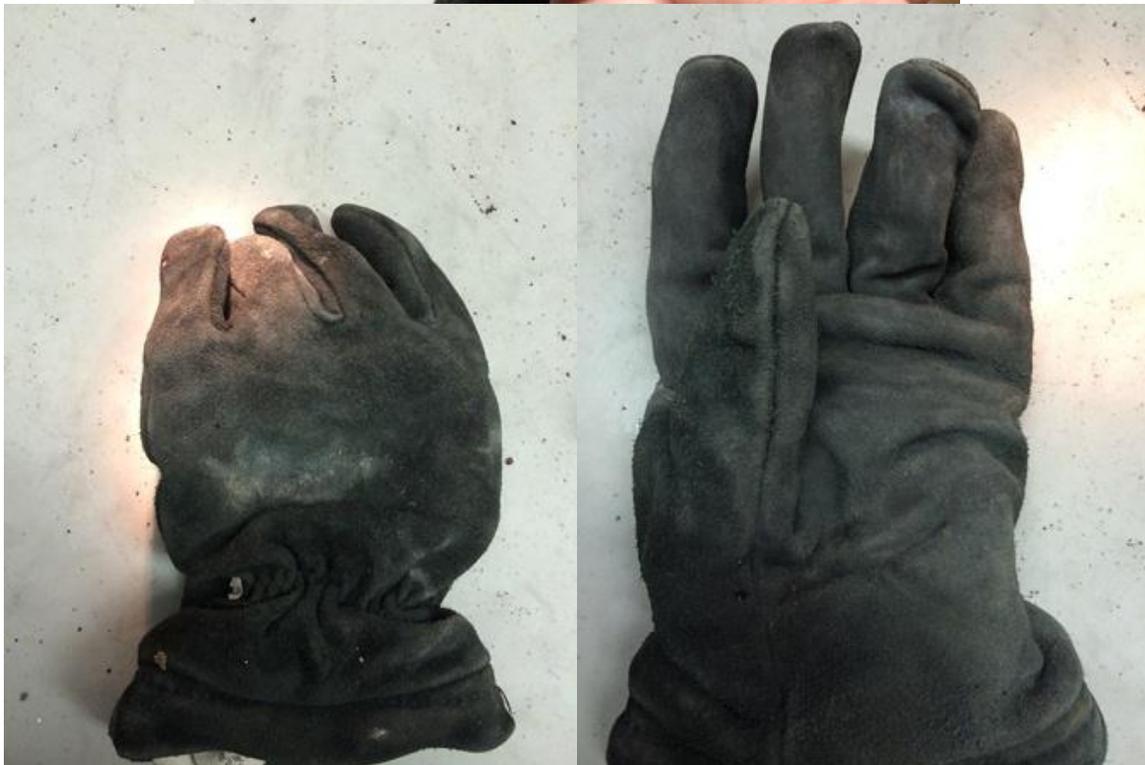
Gloves

- Spots on both gloves, front and back
- Label of right glove

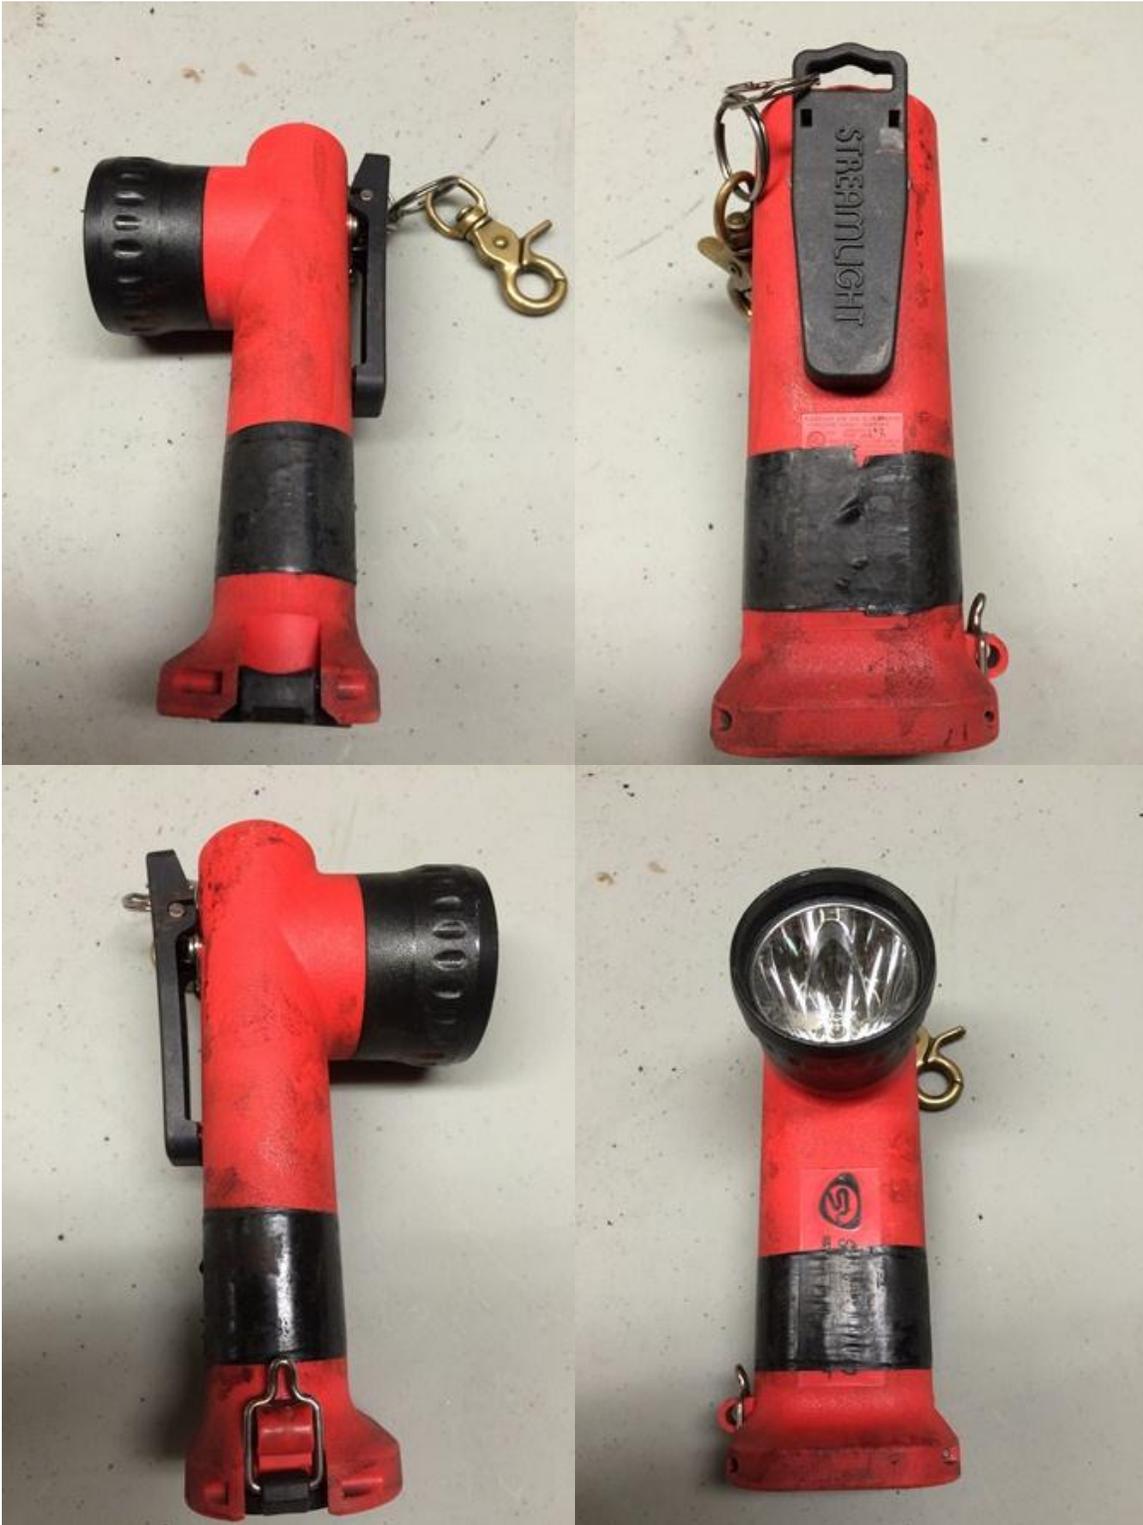
Flashlight

- All four sides of the flashlight including the black plastic clip on its back.

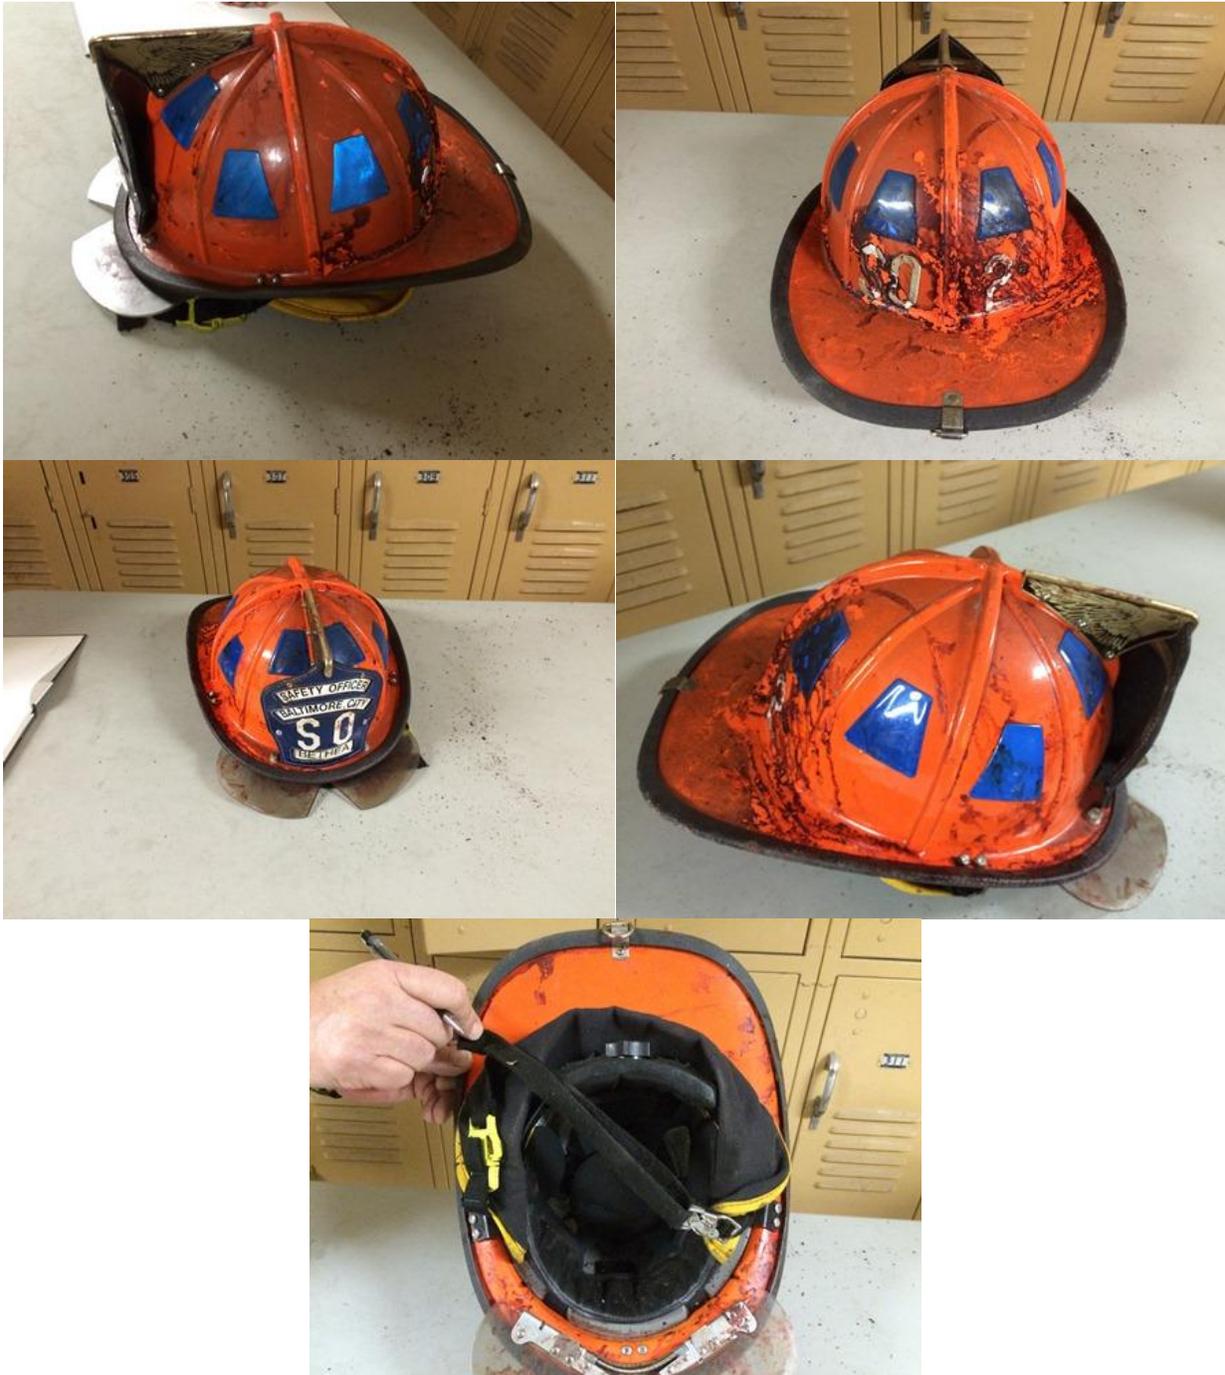
- Exterior and interior shell
- Helmet liner
- Front shield
- Eye shields (attached to front of helmet)

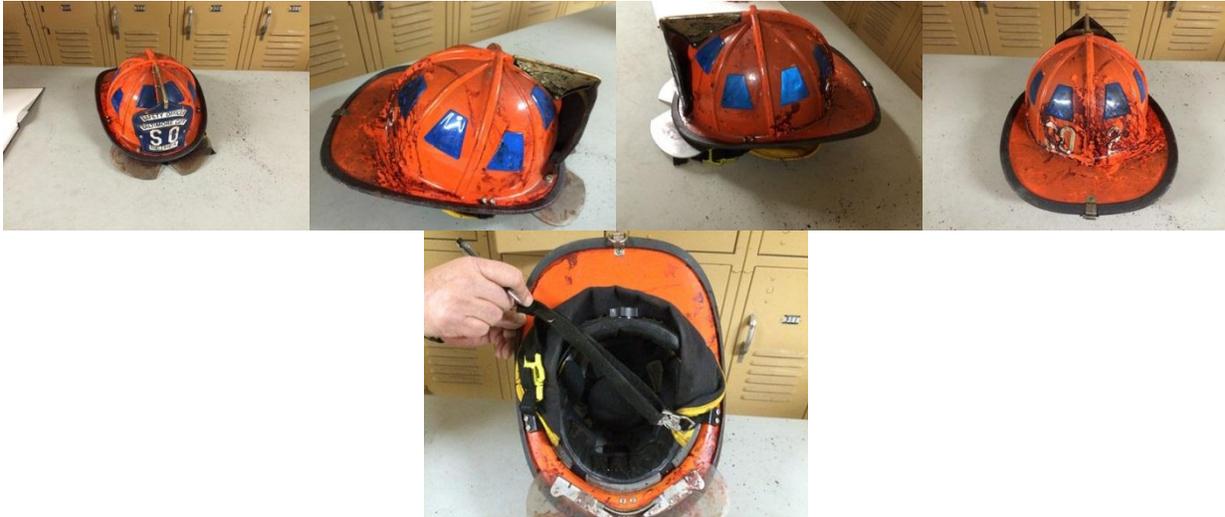
Helmet

The helmet appeared to have two cracks to its exterior shell to the left of the front shield.

- #1 crack was approximately 3 inches long and appeared to have breached the exterior shell showing a similar crack on the interior side in the same area.
- #2 crack was approximately 1 ¼ inches long and did not appear to have breached the exterior shell

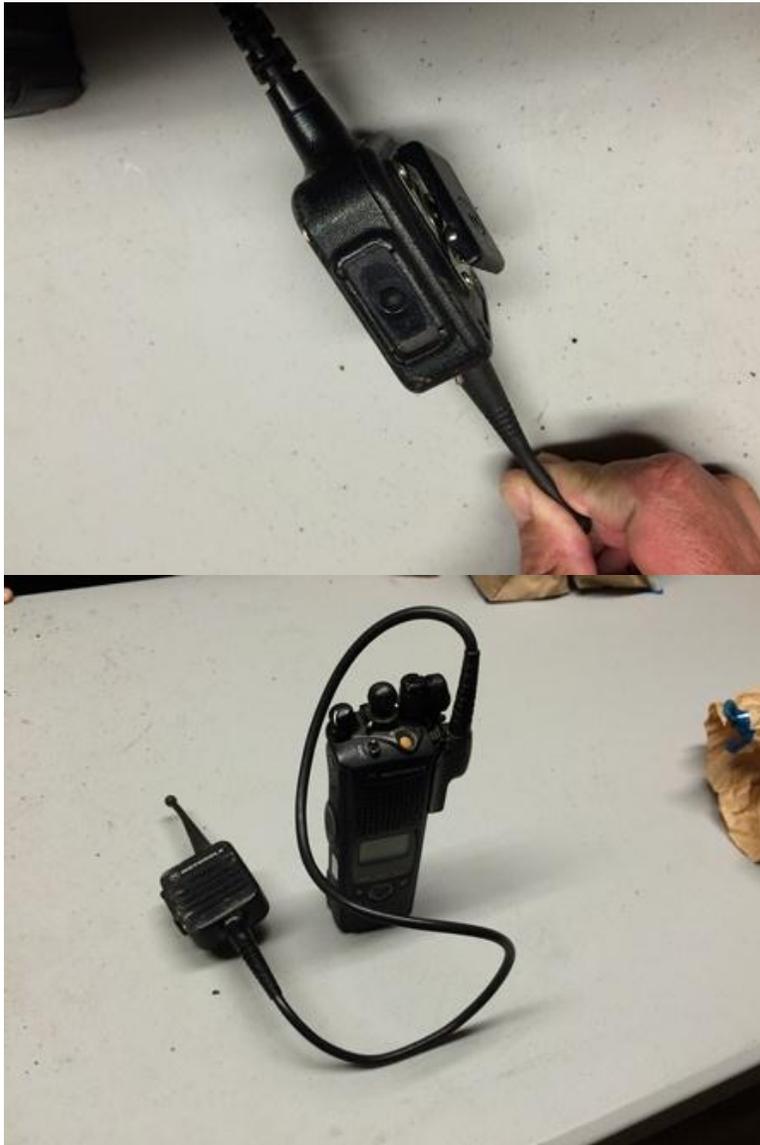
Portable Radio with Lapel Microphone

- portable radio found in left pocket of turnout coat
- portable microphone found attached to upper left side of turnout coat
- portable microphone push to talk plastic dust cover was not attached
- portable radio was on FG1 / A16 and in the “on” (powered up) position

A plastic dust cover that covered the push-to-talk (PTT) button on the portable radio's lapel microphone was missing, exposing the PTT button. An extensive search of the basement of 710 E. North Avenue did not locate the missing cover. The Board of Inquiry spoke to the member that Lieutenant Bethea relieved on the morning of November 11, 2014, and he said the PTT dust cover was present when he passed the radio to Lieutenant Bethea.

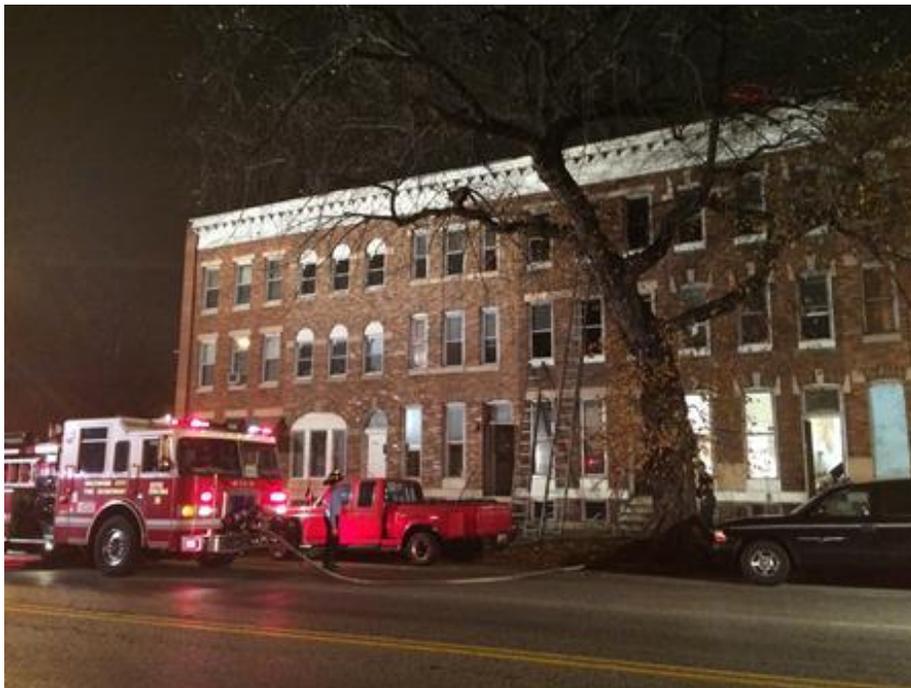
The photograph taken at 0105 hours (see below) showed that the dwelling's front room was brightly illuminated with a fire department floodlight. There was no visible smoke in the photo. If Lieutenant Bethea entered 710 E. North Avenue while the floodlight was on, The Board of Inquiry believed that the bright light may have caused his pupils to constrict, thereby compromising his night vision and diminishing his ability to see in the dark interiors of the middle room, hallway leading to the rear kitchen and the kitchen area where the floor was missing.

The Board of Inquiry believed that Lieutenant Bethea unknowingly walked off the unprotected ledge and fell to the basement floor below where he struck his face and head on assorted debris with enough force to cause facial trauma and crack the outer shell of his helmet. The Board of Inquiry believed that Lieutenant Bethea may have suffered a concussion from the fall, and may have been disoriented from it. He may have lost consciousness for a period of time. The Board of Inquiry believed that Lieutenant Bethea fell into an IDLH (smoke-laden) atmosphere that included carbon monoxide (CO) and airborne soot.
