## **Volunteer Fire Fighter Caught in a Rapid Fire Event During Unprotected Search, Dies After Facepiece Lens Melts – Maryland**

### **Executive Summary**

## **Volunteer Fire Fighter Dies After His Facepiece Failed From Being Caught in a Rapid Fire Event—Maryland**

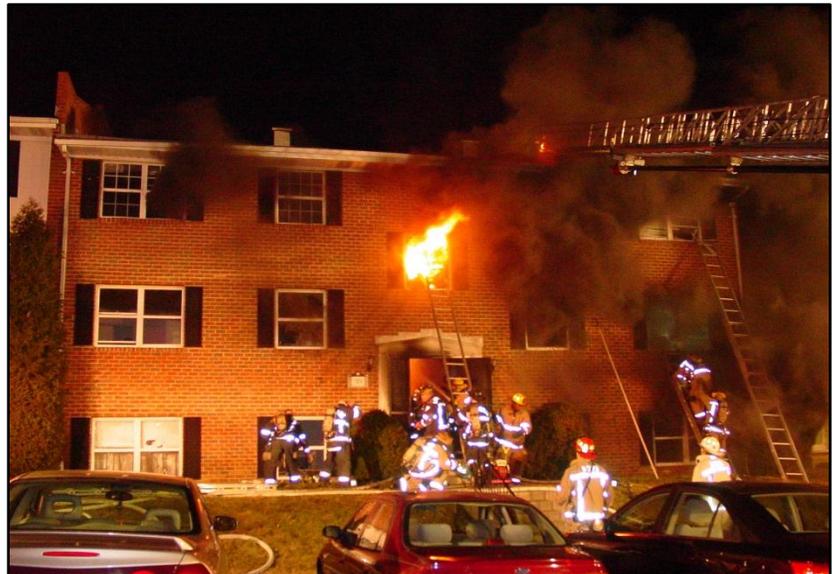
**Rapid fire event exiting window in common stairwell of apartment building. (Photo courtesy of fire department.)**

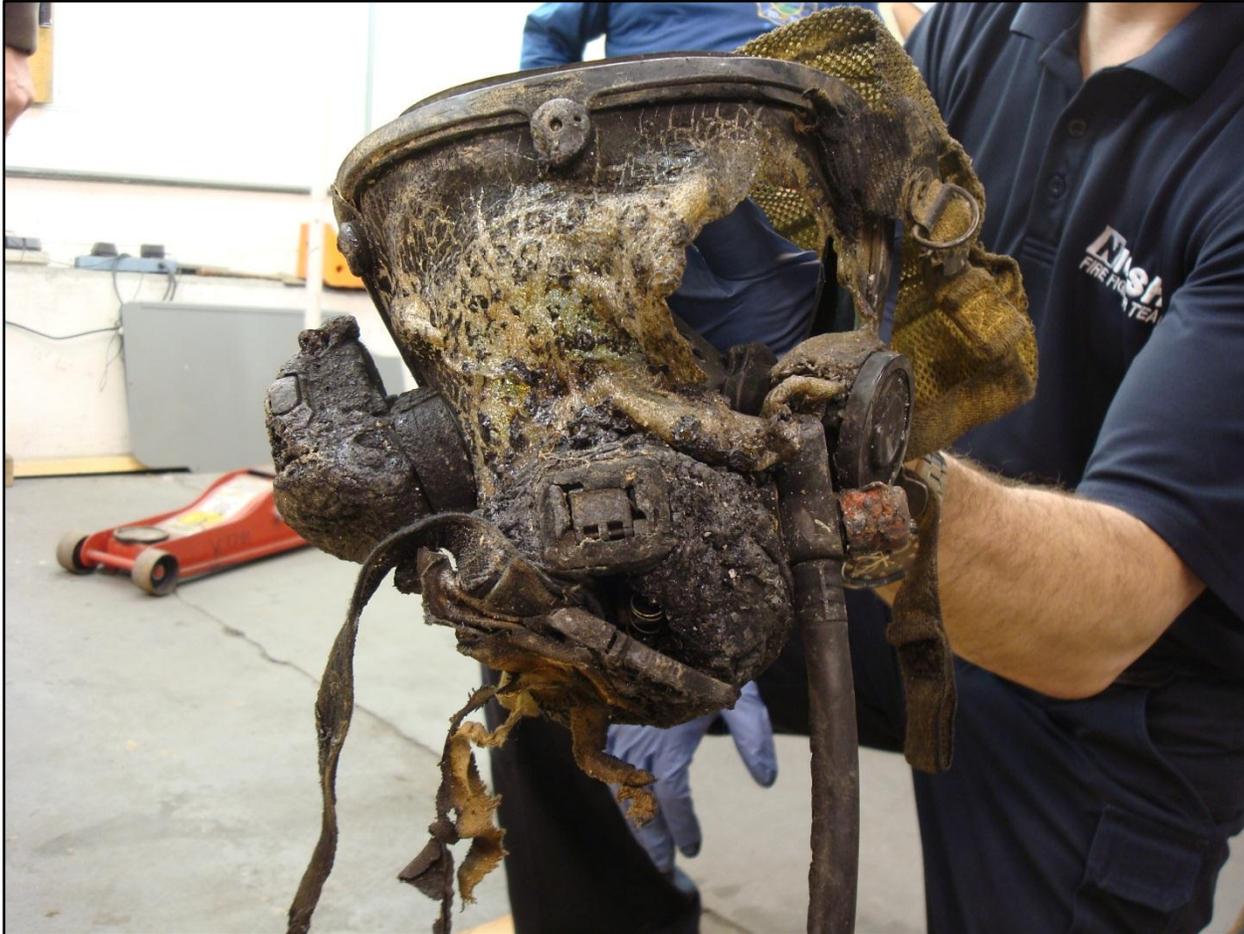
The victim’s SCBA was submitted to the National Personal Protective Technology Laboratory (NPPTL) NIOSH for evaluation. The SCBA was delivered to NPPTL on March 8, 2011, and inspected on April 12, 2011. The unit was identified as a 4500-psig SCBA (NIOSH approval number TC-13F-212, 45-minute duration unit). The SCBA suffered extensive damage from heat and fire and was covered with dirt, grime, foreign particulate material, and soot. The SCBA facepiece lens was melted with a hole penetrating the lens material (see Photo 1). The cylinder valve, as received, was damaged; the hand wheel was operable. All gauges were unreadable and heavily damaged. The regulator and facepiece were heavily damaged and unusable, and the regulator plastic materials had been melted and were bonded onto the facepiece. The SCBA air cylinder was heavily damaged and burned. The outside cylinder covering was black, and the labeling was unreadable. The air cylinder was so heavily damaged that the name of the manufacturer, date of manufacture, DOT number, and re-test date label were unreadable. Because of this, a cylinder re-test date could not be determined. In light of the condition of the SCBA obtained during this investigation, NIOSH was not able to test and returned the unit to the fire department. The full SCBA evaluation report is available from NIOSH upon request.

**Photo 1. Victim's melted facepiece lens.**  
*(NIOSH Photo.)*

Although there was no indication of any manufacturer defect with the victim's SCBA, the conditions encountered likely exceeded the capability of the SCBA facepiece lens.

***Recommendation #16: Research and standard-setting organizations should conduct research to more fully characterize the thermal performance of facepiece lens materials of self-contained breathing apparatus (SCBA) and components of other personal protective equipment (PPE) to ensure SCBA and PPE provide an appropriate level of protection.***

Discussion: A number of recent NIOSH investigations, including this incident, suggests that the facepiece lens material may have melted before other components of the fire fighter's self-contained breathing apparatus and personal protective equipment ensemble.<sup>32-35</sup> Additionally, a number of documented near-miss incidents also identify the potential for thermal damage to facepiece lenses is greater than commonly believed.<sup>36-39</sup>

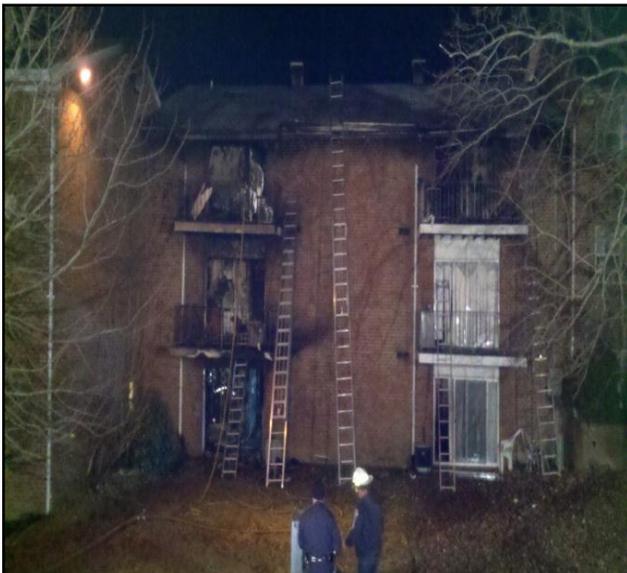
**Photo 2. Orientation of Side C. Second and third floor balconies are on the left.**  
*(Photo courtesy of fire department.)*

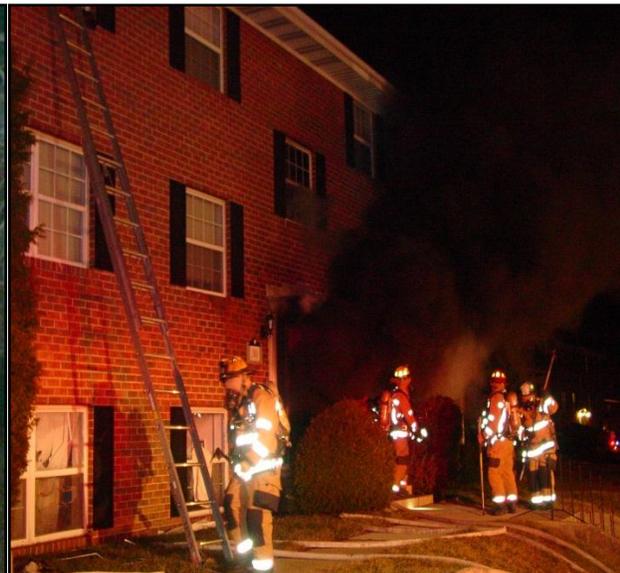
**Photo 3. Smoke exiting up stairwell through open door.**  
*(Photo courtesy of fire department.)*

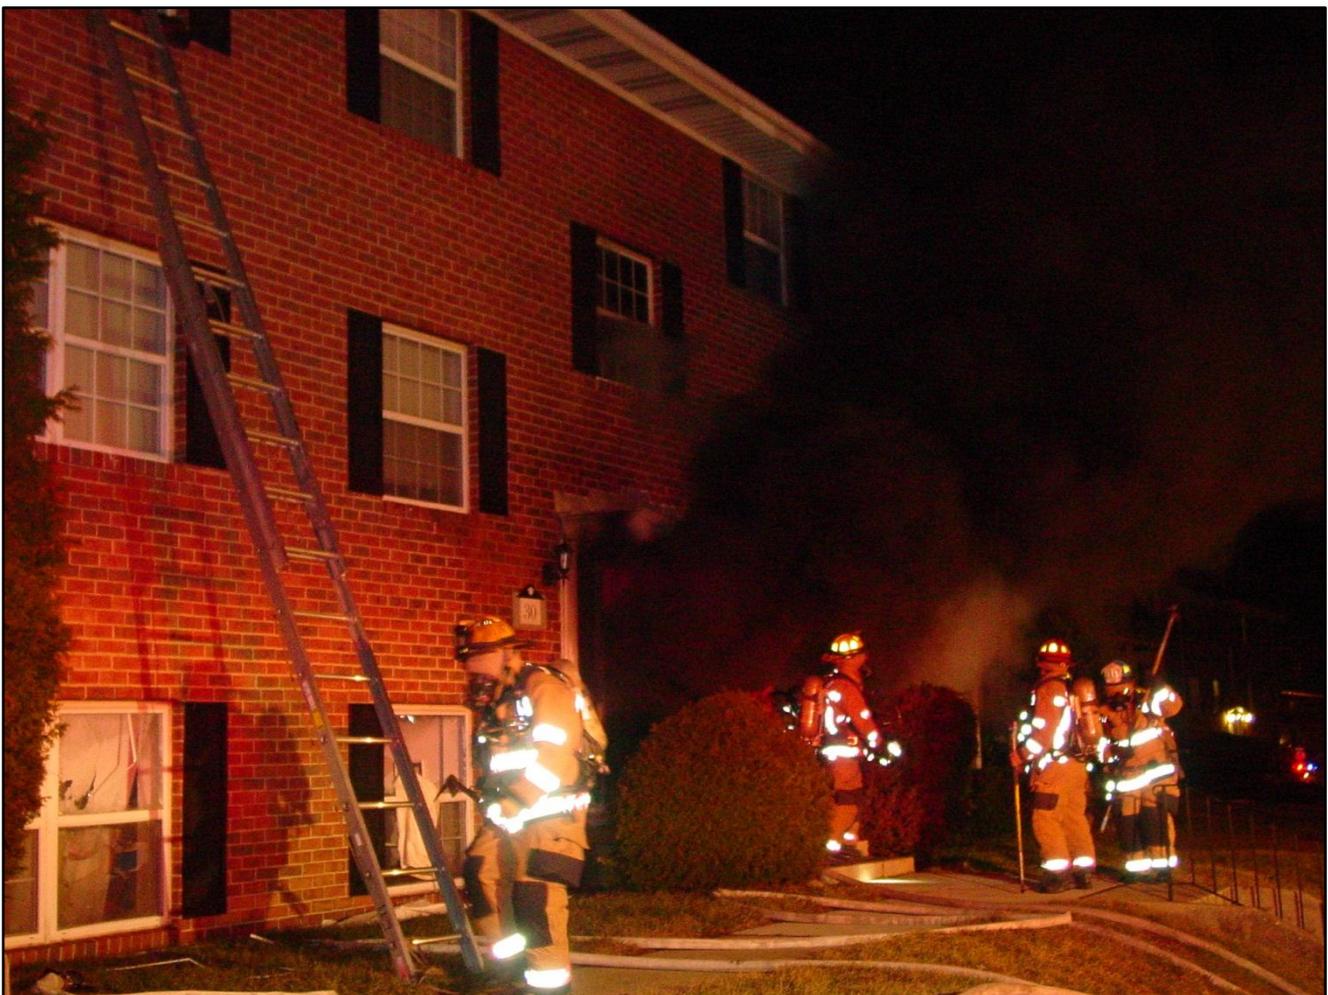
**Photo 4. Ladder to window where civilian woman was rescued upon arrival. This is Side-A; the building designation of the apartment was 3A.**  
*(Photo courtesy of fire department.)*

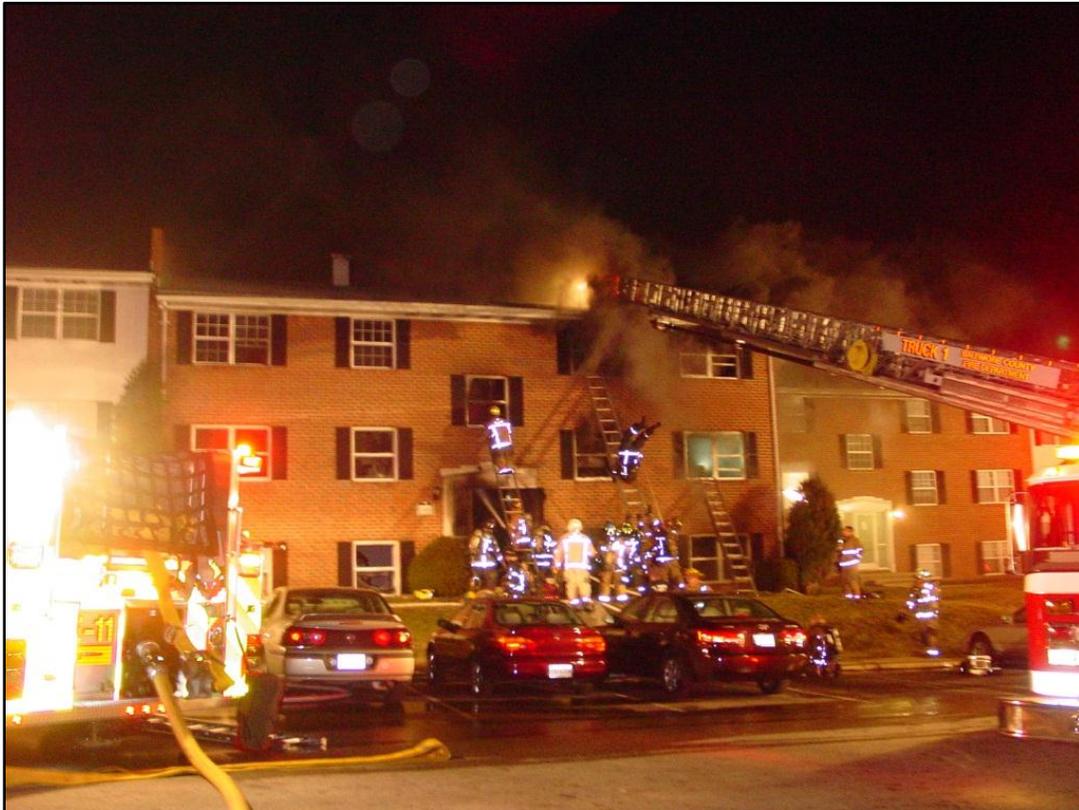
**Photo 5. SQ303 fire fighter bailing out of a third-floor window.**  
*(Photo courtesy of fire department.)*

Once a ground ladder was placed at the window, the SQ303 fire fighter bailed out of the third-floor window, head-first, at 1842 hours (see Photo 5). A fire fighter from E301 was aware of the circumstances and was able to partially catch the SQ303 fire fighter to break his fall and help reduce the severity of injury. The E301 driver assisted the fire fighter after he bailed out of the window. The SQ303 driver asked where the victim was and learned that the victim was still inside. The SQ303 driver grabbed the E301 crew and made re-entry. They saw the T1 driver operating a handline through the window and took it from him and advanced it to the third-floor landing. During this time, the victim was attempting to give his LUNAR (location, unit number, assignment, resources needed) and called for a Mayday at 1847 hours. *Note: The victim mistakenly gave his position as the third-floor alpha/bravo corner, which is why they searched Apartment 3A.*

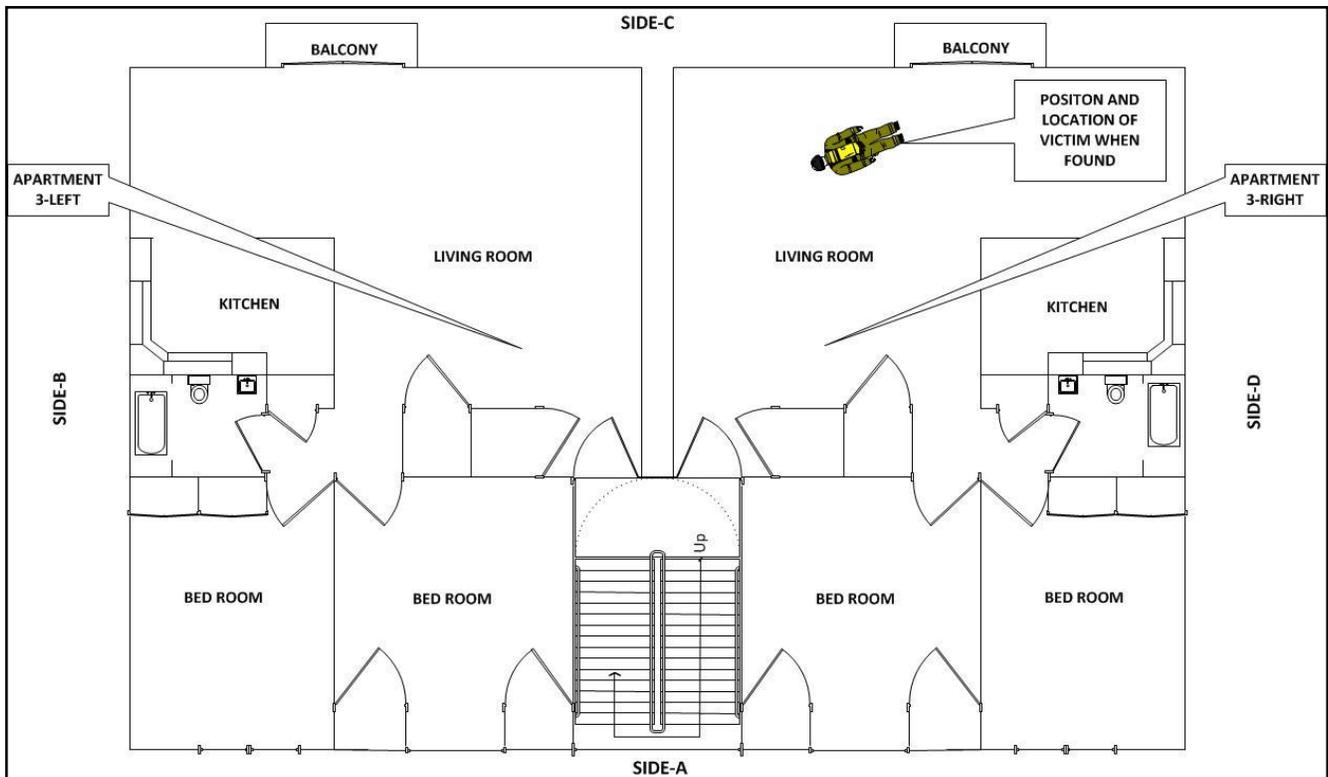
**Diagram. Typical apartment layout.**
