Line of Duty Death
Board of Inquiry Report
Lieutenant James E. Bethea

710 E. North Avenue

November 12, 2014

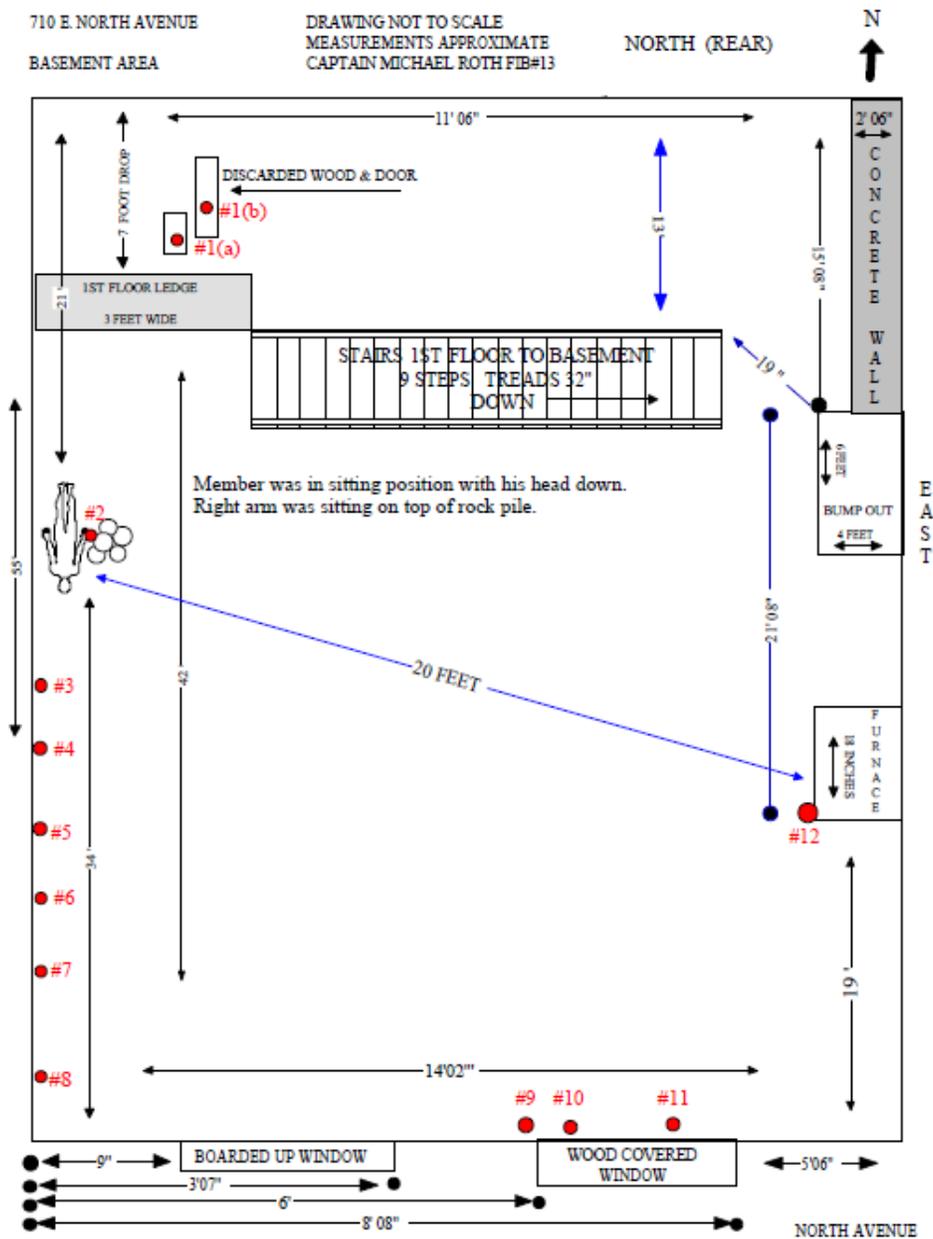
Basement 710 E. North Avenue

Examination of the basement area revealed Lieutenant Bethea's body in a seated, upright position facing north, toward the rear (side charlie) wall and next to the west (side bravo) wall. His right arm was resting upon a pile of broken-up concrete. He was approximately 21 feet from the north wall and 34 feet from the south wall. He was in full turnout gear with his flashlight and radio microphone attached to the left side of his turnout coat. The portable radio was inside the left pocket of his turnout coat. His left glove was on his left hand and his right glove was off of his right hand and was clinched in his left hand. The flashlight and radio were in the "on" position and working. The flashlight's beam was dim. His helmet was sitting just off his right leg and showed pooling of blood on it. His nose was still dripping blood from the nostrils. Signs of facial trauma were present.

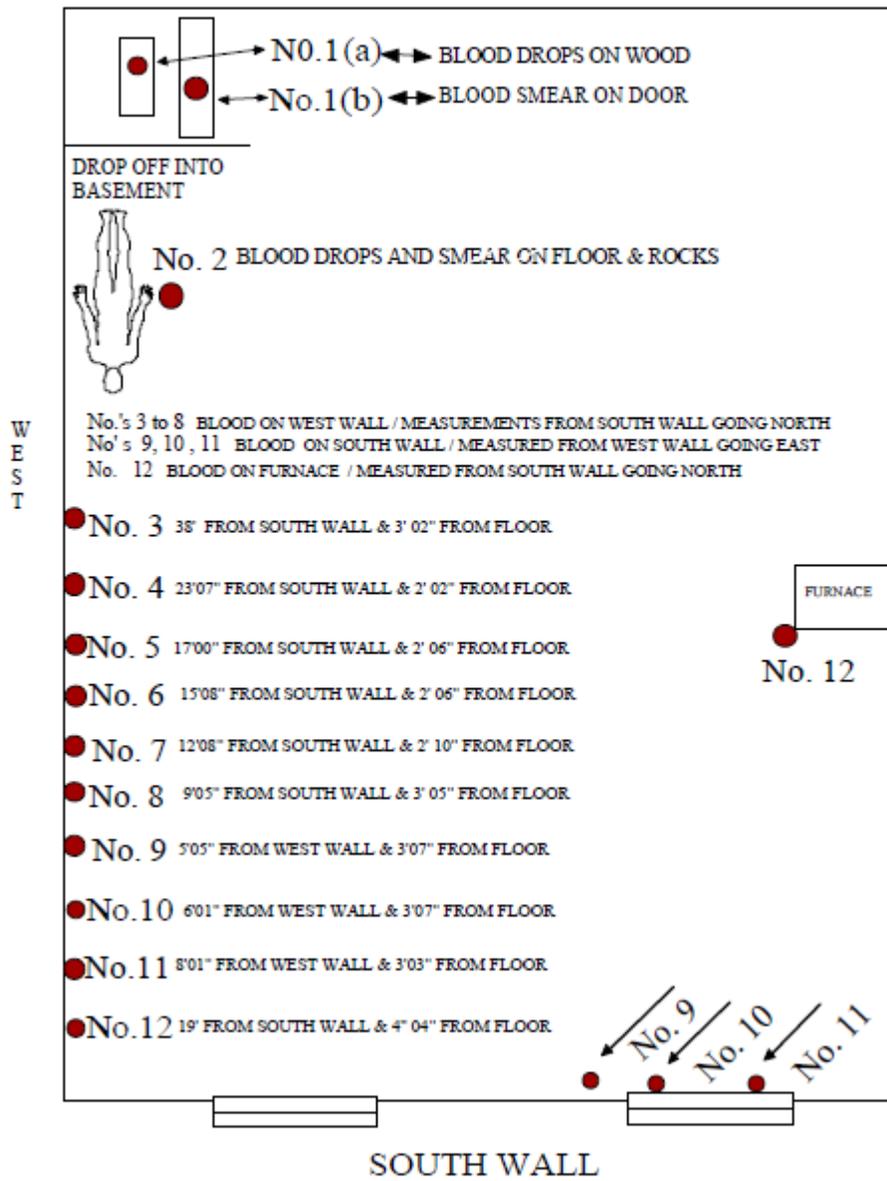
MEASUREMENTS APPROXIMATE
DRAWING NOT TO SCALE
BLOOD EXAMINATION

The following is a description of blood found in the basement of 710 E. North Avenue. See the diagram in Appendix F4 for more information.

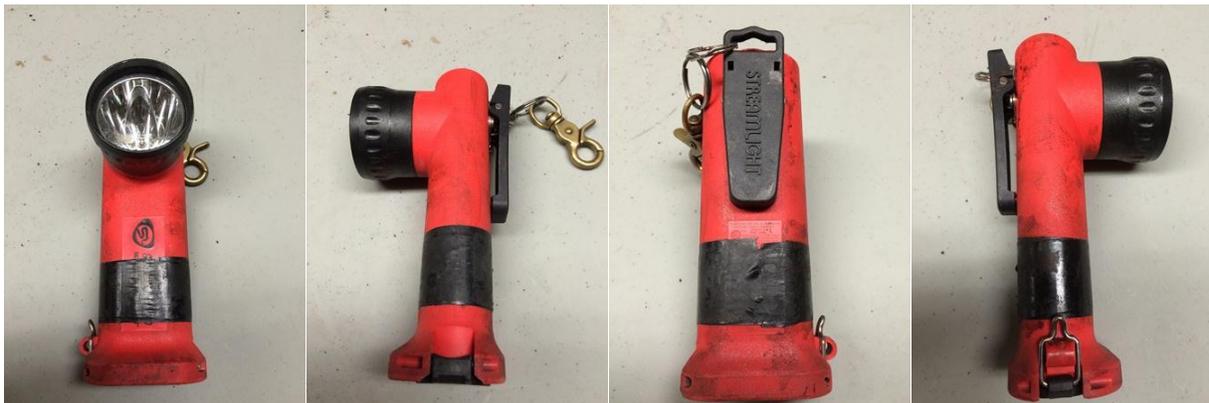
Flashlight

Streamlight Survivor in the "on" (powered up) position
